Cromwell Bottom Outline Water Level Management Plan

Final Report

March 2022

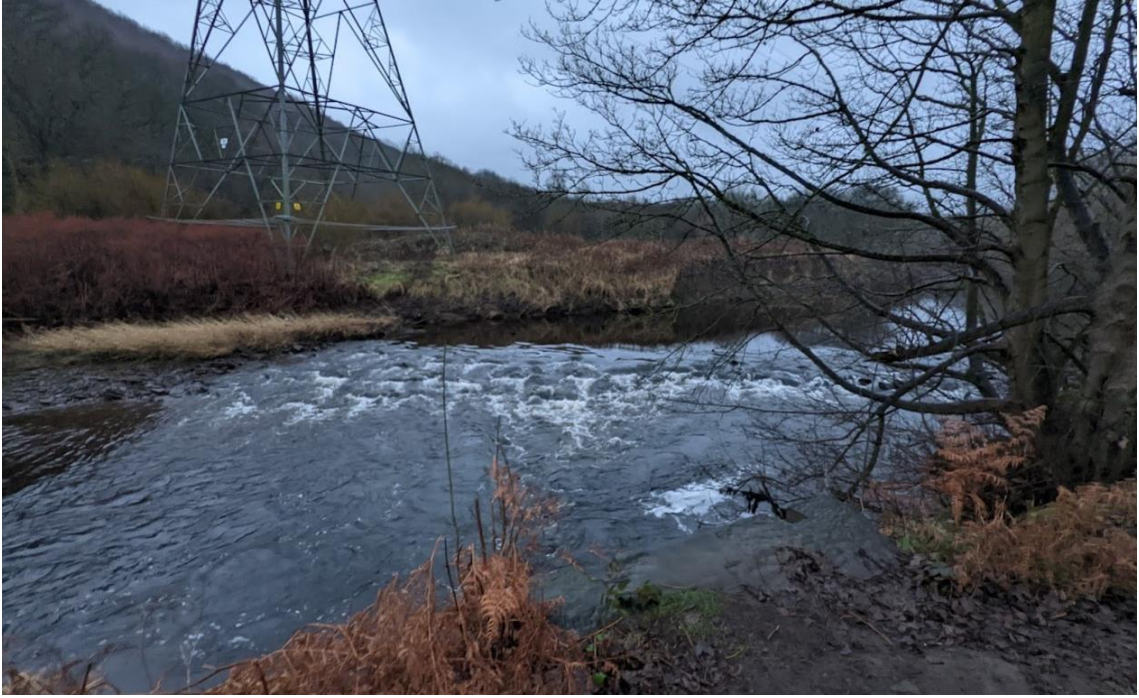
No.	Photographs and Descriptions
2	<p>The River Calder forms the southern boundary of the wetland</p>

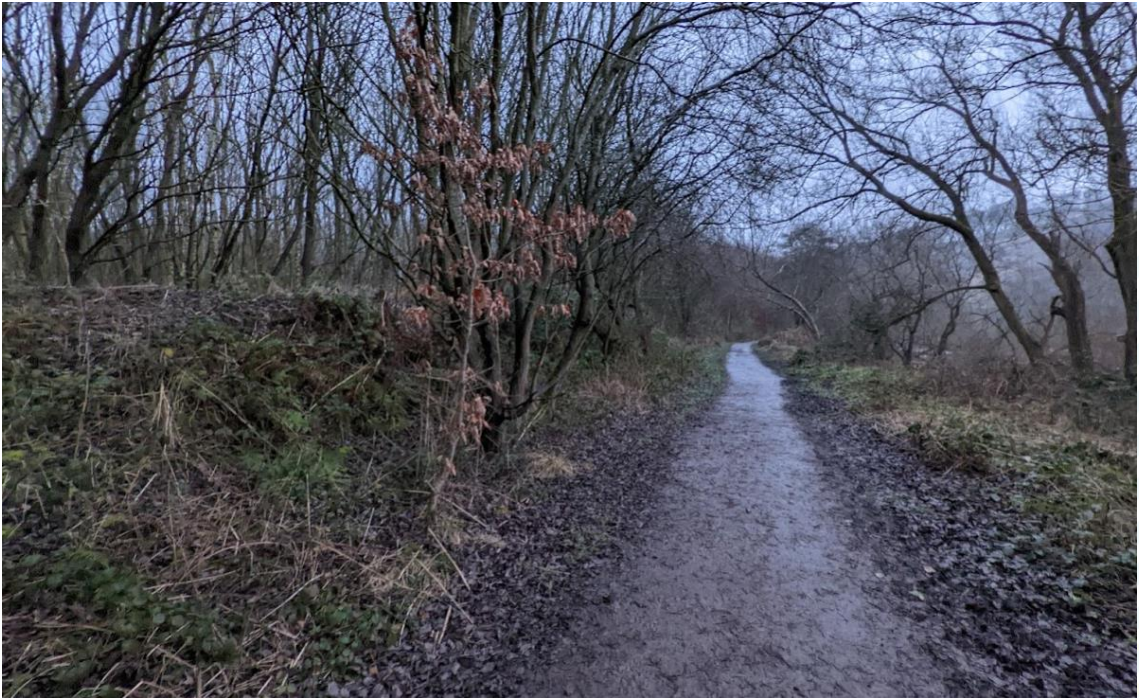
3	<p>The wetland is surrounded by an embankment on all sides. This appears from site observations to be a remnant of the PFA deposited on the site.</p>

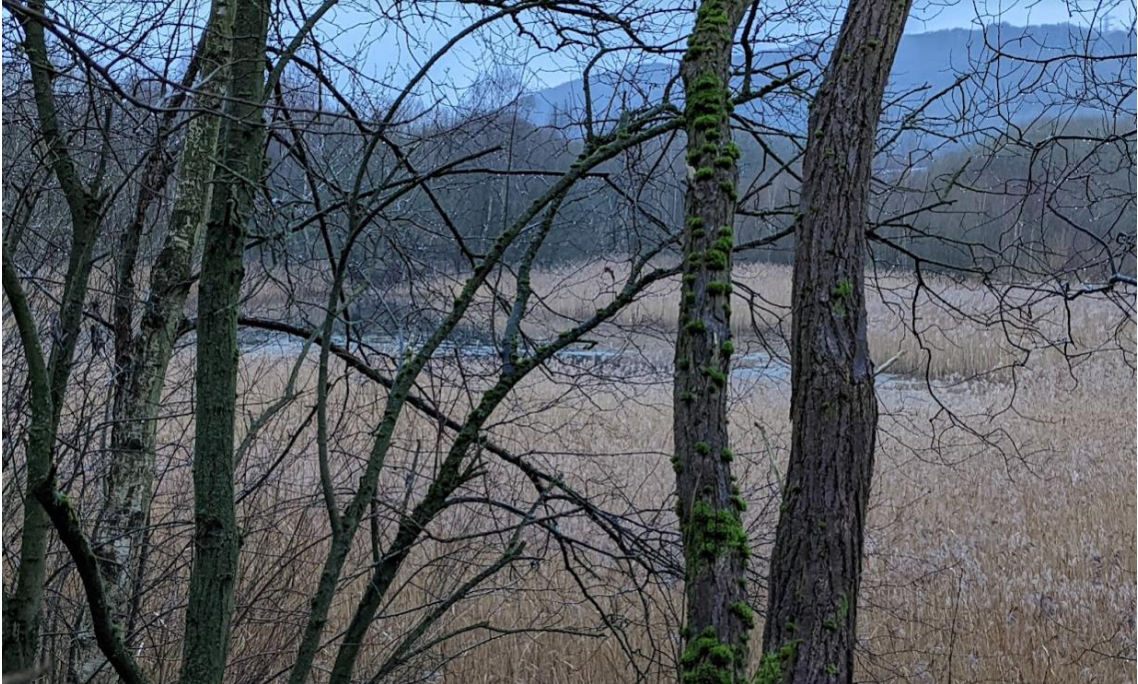
No.	Photographs and Descriptions
4	<p>A lagoon occupies the lowest part of the site surrounded by reedbeds.</p>

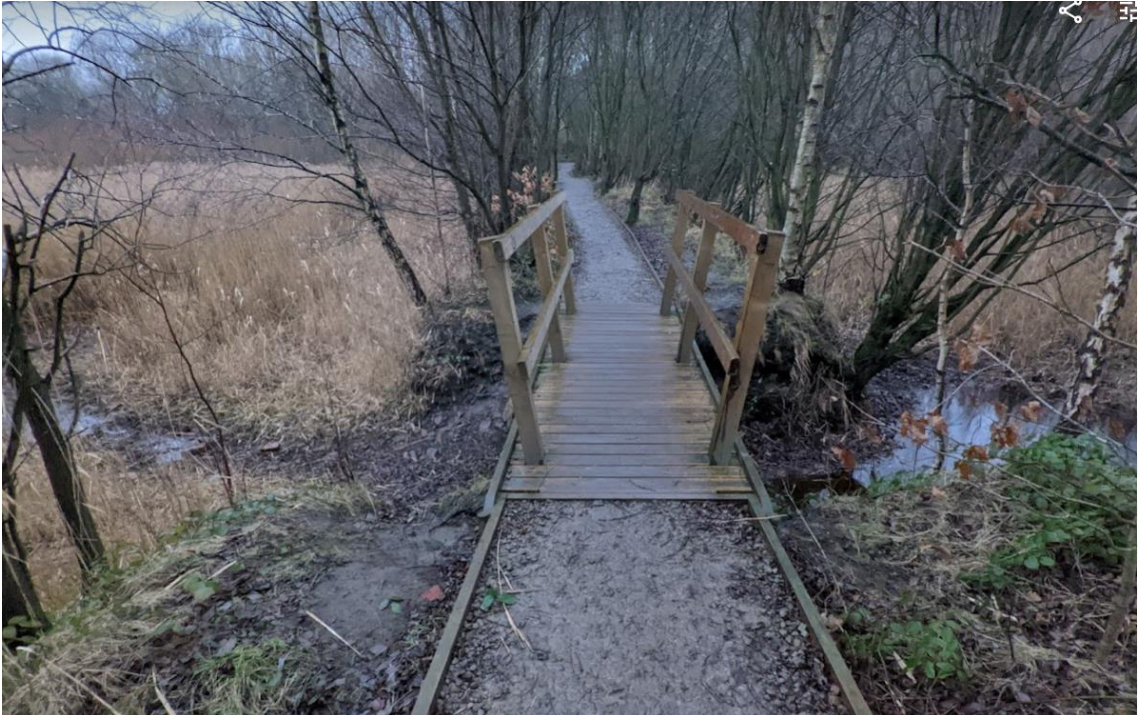
5	<p>On the eastern boundary of the Lagoon is a bund that runs north-south. In the centre a ditch has been cut through. This ditch runs into the lagoon westwards and peters out as it runs through the wet woodland to the east.</p>

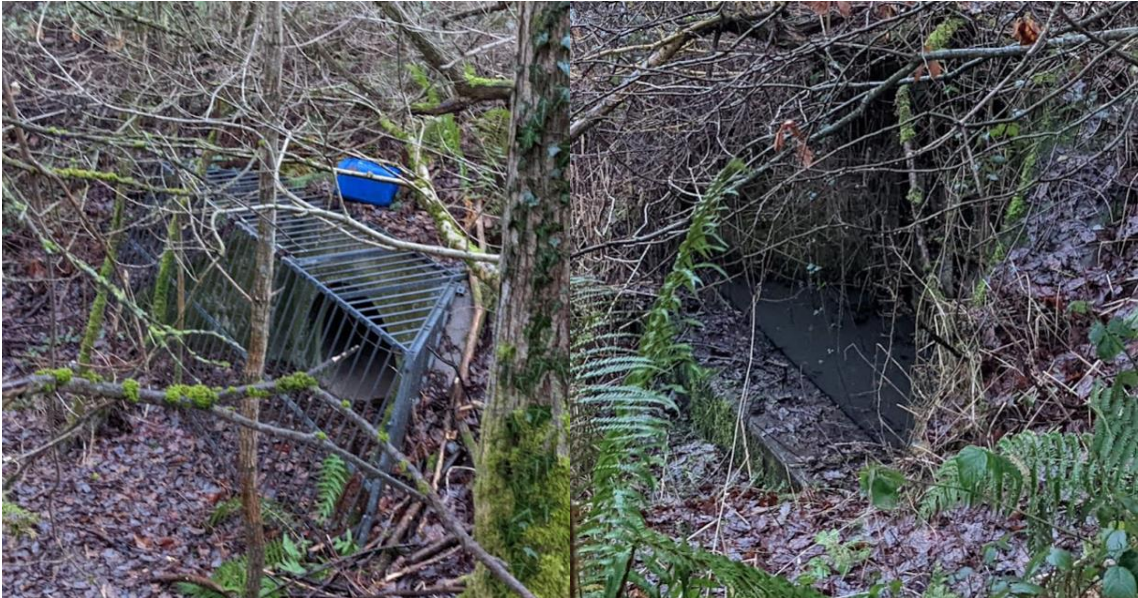
No.	Photographs and Descriptions
6.	<p>The hollow in which the wetland lies has one outfall through the embankment. This is a culvert set at 57.15mAOD</p> <p>Observations by CMBC suggest that water rarely reaches this level, perhaps only in times of flood from the river.</p>

Observations by CMBC show that this outfall does not operate every winter and only really operates in times of flood. Overall, this suggests that rainfall and evapotranspirational losses are relatively equal over a year. If rainfall inputs were larger, then water levels would reach the height of the outfall and discharge out.

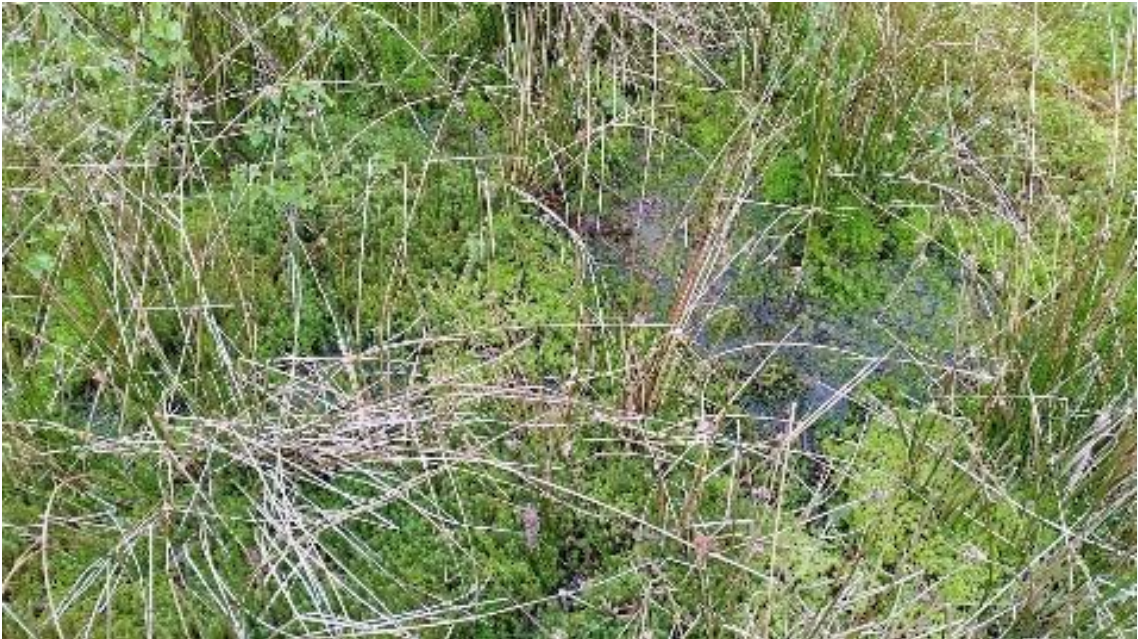
8	<p>In the North-East of the site is a topographical hollow containing a Sphagnum Lawn. The hollow is formed by an embankment on three sides and rising ground in the west.</p>

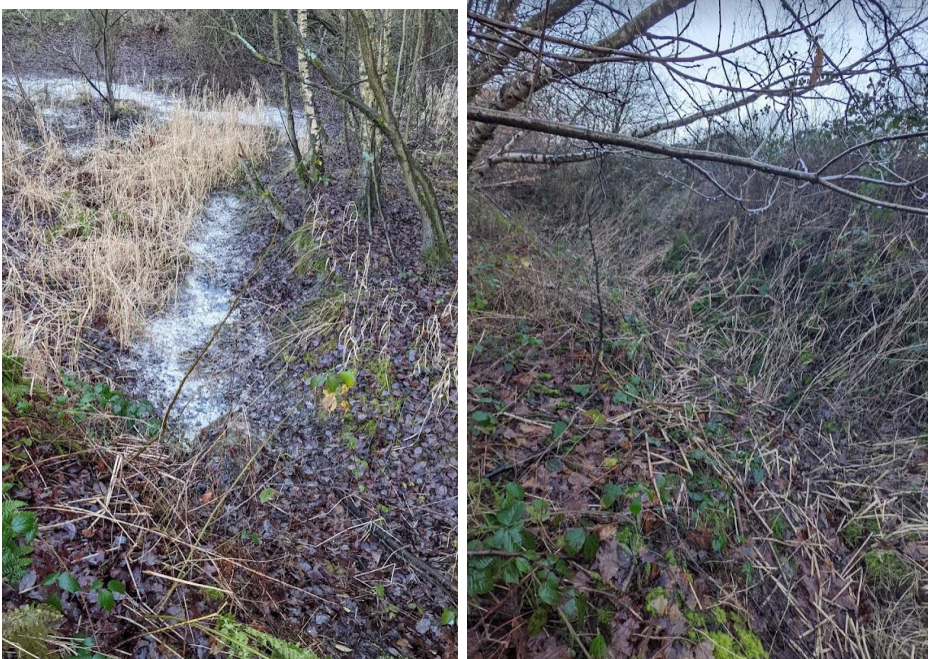
No.	Photographs and Descriptions
9.	<p>There is a small ditch running from the Sphagnum Lawn through a section of raised ground to the main hollow. This drain is filled with vegetation and is blocked by a path at the western end. It appears that it still acts as a flow pathway in wet conditions to allow the sphagnum lawn hollow to drain.</p>
